CALSPAN ON-SITE AIR BAG DEPLOYMENT INVESTIGATION

CALSPAN CASE NO. 95-09

VEHICLE #1 - 1992 FORD TAURUS GL STATION WAGON (AIR BAG EQUIPPED)

VEHICLE #2 - 1989 CHEVROLET S10 PICKUP TRUCK

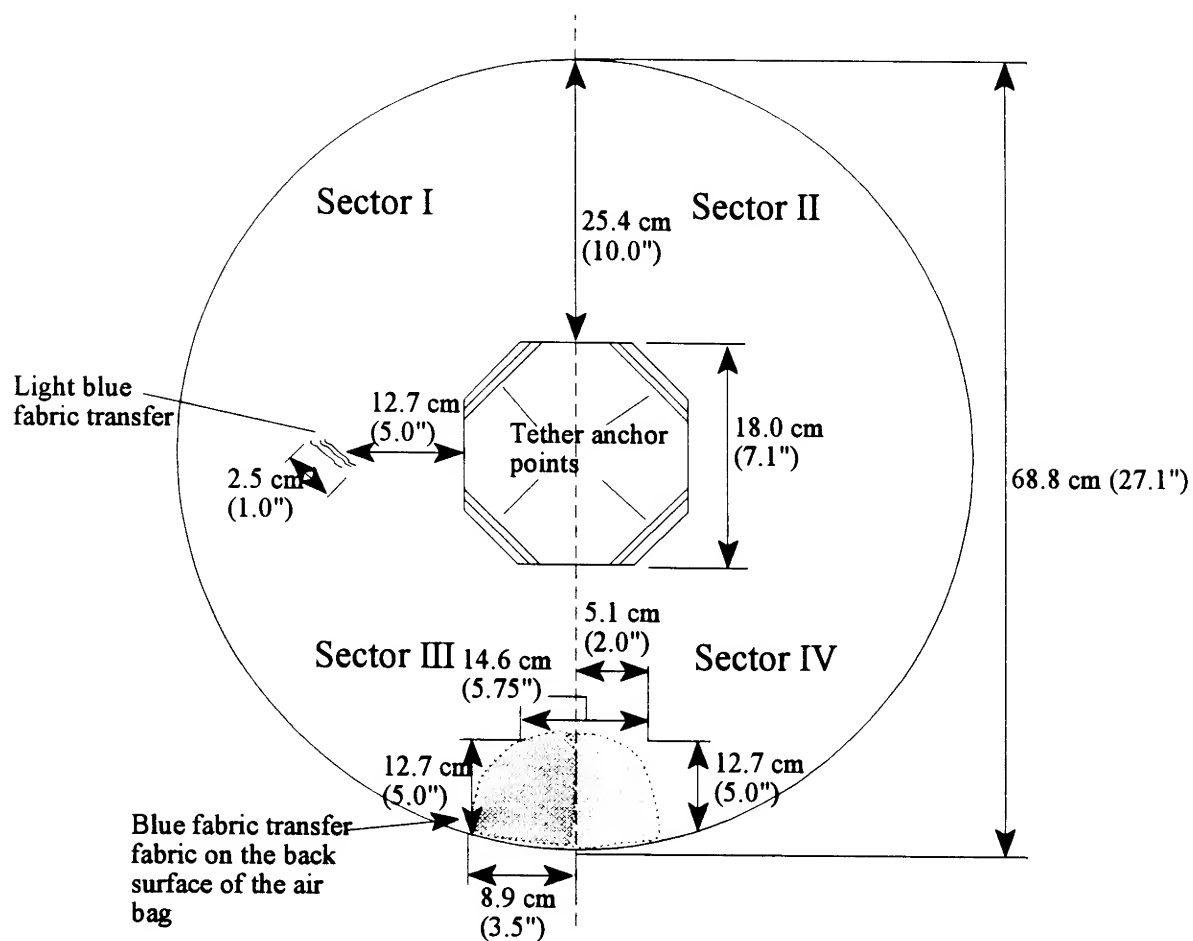
Front Surface of The Driver Side Air Bag

The driver air bag exhibited transfers which were consistent in color with the color of the driver's shirt (refer to photographs #49, #50 on page A-25). A 2.5 cm (1.0") long light blue transfer was noted on the front surface of the air bag located 12.7 cm (5.0") left of the center "target" area. A large blue/gray fabric transfer measuring 14.6 cm x 12.7 cm (5.75" x 5.0") was noted on the back surface of the air bag in the six o'clock sector. It was located along the perimeter of the air bag and had an appearance of a heavier transfer coloration along the left side of the transfer (refer to air bag diagrams on pages 13-14 for detailed documentation). This transfer resulted from contact with the driver's abdominal area.

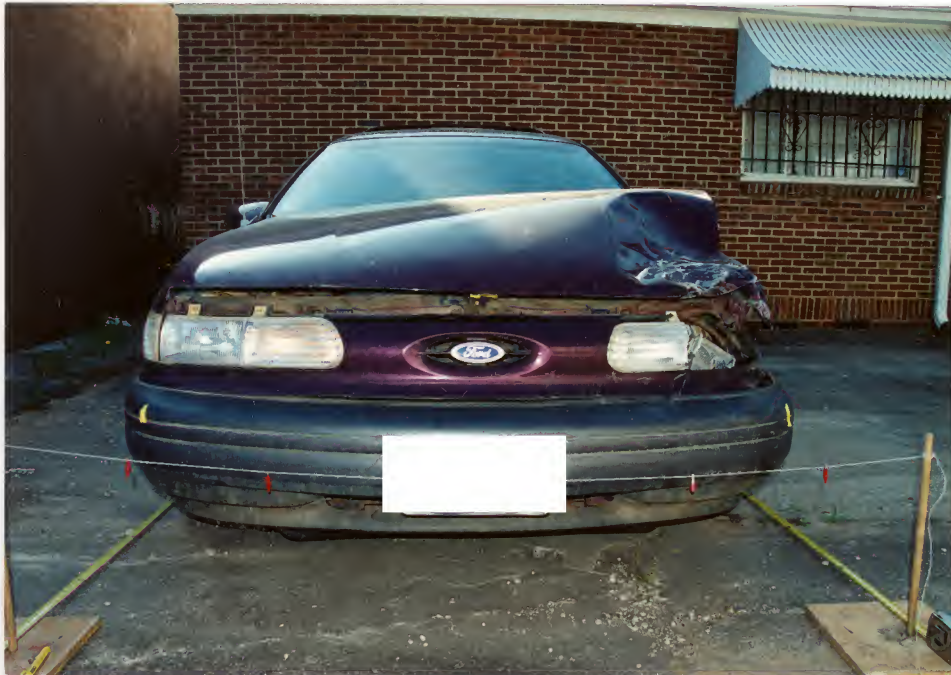
The frontal plane of the 1992 Ford Taurus GL station wagon struck the frontal plane of the 1989 Chevrolet S10 pickup truck. Direct contact was noted at the left front corner of the bumper surface, grille, and hood area. The front bumper sustained a maximum rearward displacement of 3.8 cm (1.5") and the left corner of the hood was displaced rearward a maximum of 38.1 cm (15.0"). The combined direct and induced damage length measured 139.7 cm (55.0") (refer to photographs #18, #19, #22 - #25 on pages A-9, through A-13). Measured crush values are listed below:

18. Frontal view of the 1992 Ford Taurus GL station wagon (Vehicle #1) showing the overall plane of contact.

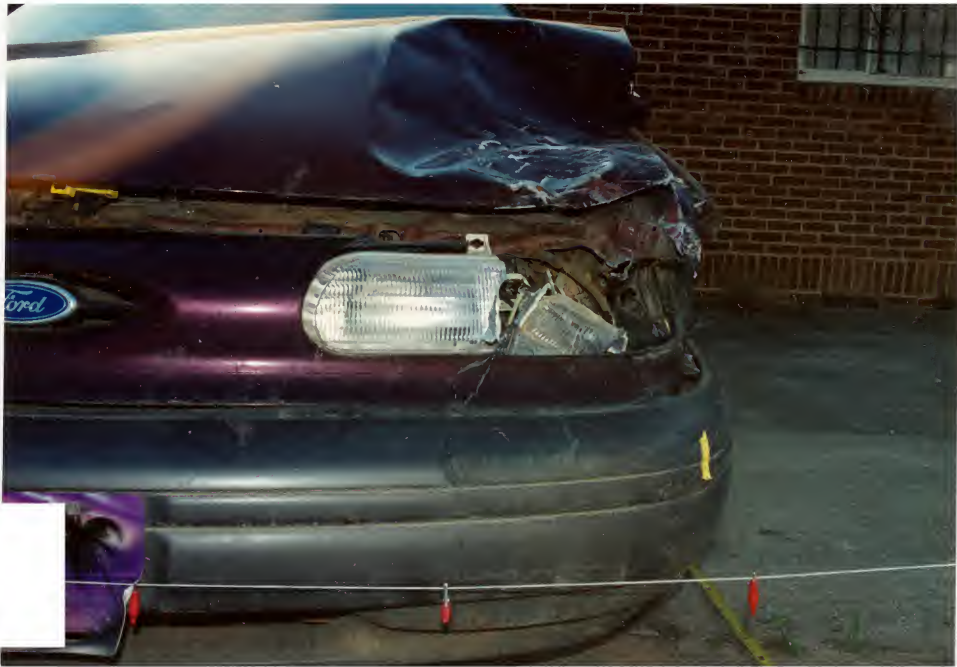
19. Closer view of the contact damage along the left front bumper, grille, and hood.

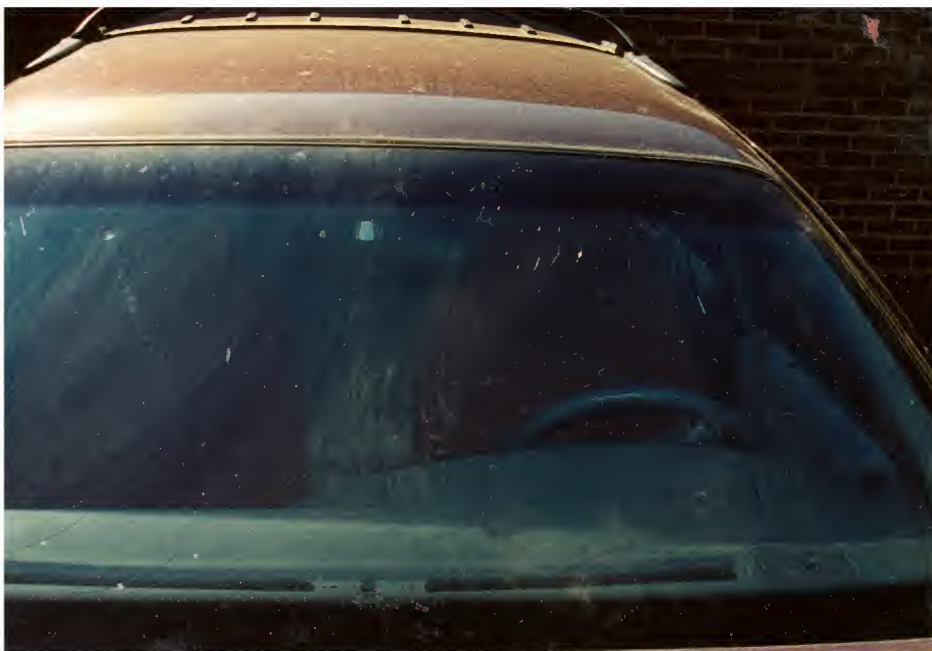
The windshield exhibited a spider web contact pattern which was consistent with an occupant hand contact. It was located 21.6 cm (8.5") left of the vehicle centerline and 11.1 mm (0.4") below the windshield header. Although the driver did not report any correlating lesion, this damage was probably caused by contact of the driver's right hand during the crash.

20. View of interior contact evidence on the windshield near the windshield header.

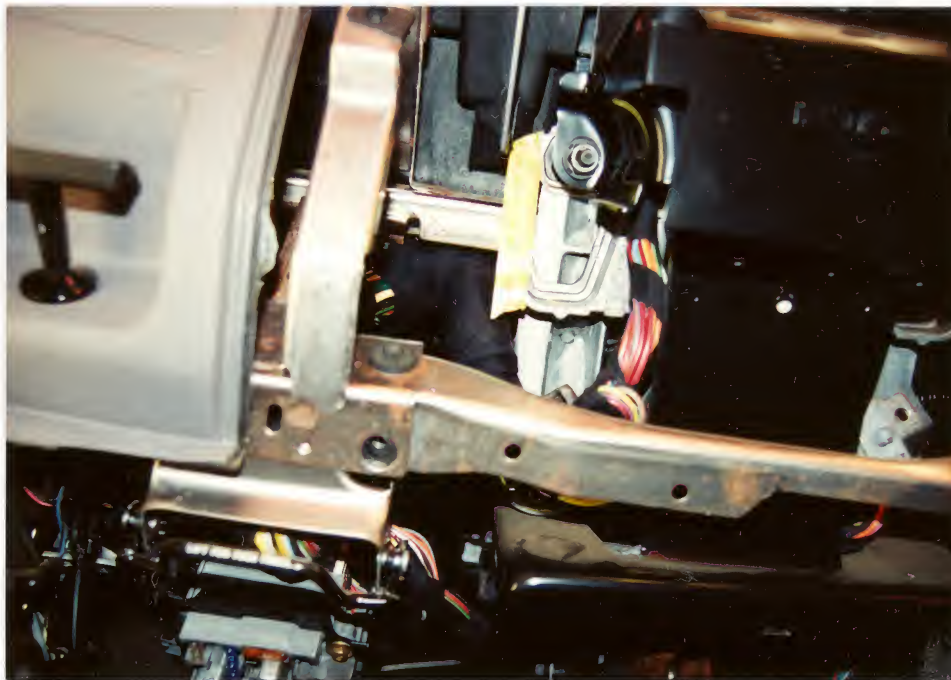
The driver continued to move forward due to the crash force and compressed the steering column energy absorption device. This was noted by the movement of the steering column shear plate which measured 4.8 cm (1.875") of displacement at the left shear capsule and 3.8 cm (1.5") at the right shear capsule. As the air bag system initiated the deployment sequence, the module cover flaps pushed against the driver's abdominal area in response to the expanding air bag. The air bag then contacted her abdominal region.

39. View of the left shear capsule showing the movement of the shear plate.

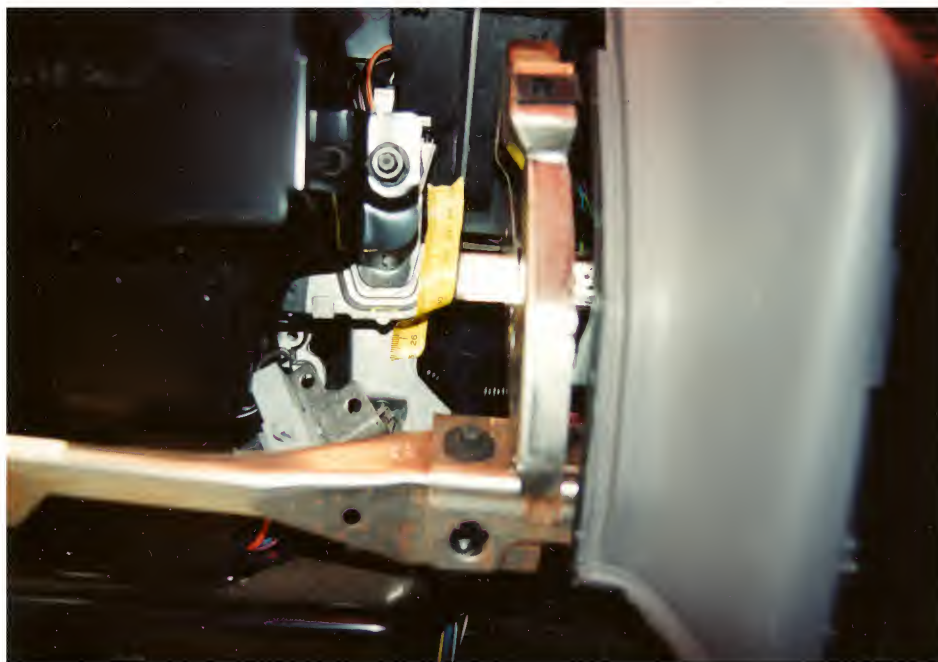
40. View of the right shear capsule showing the movement of the shear plate.

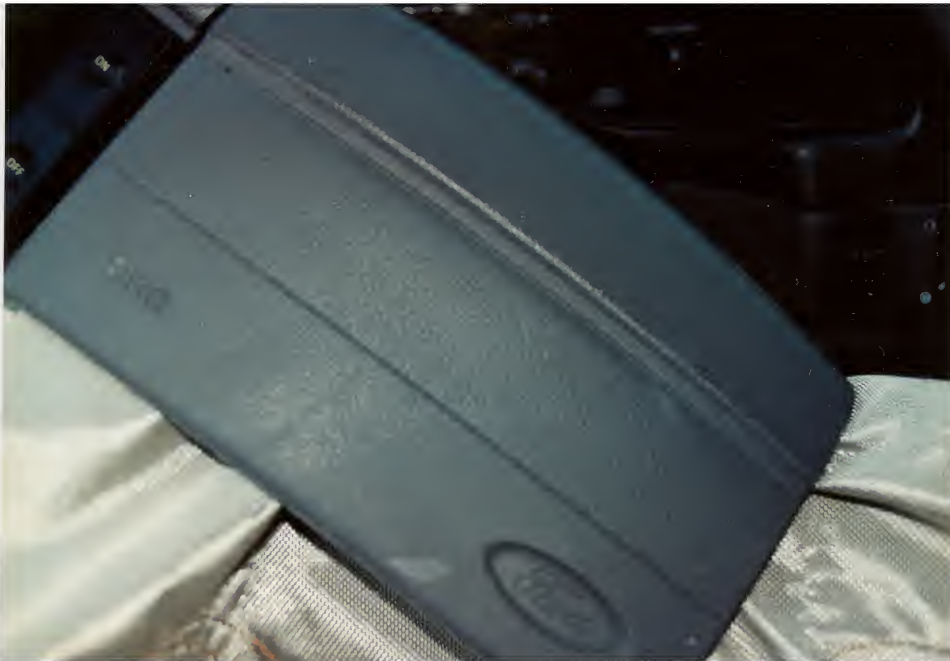
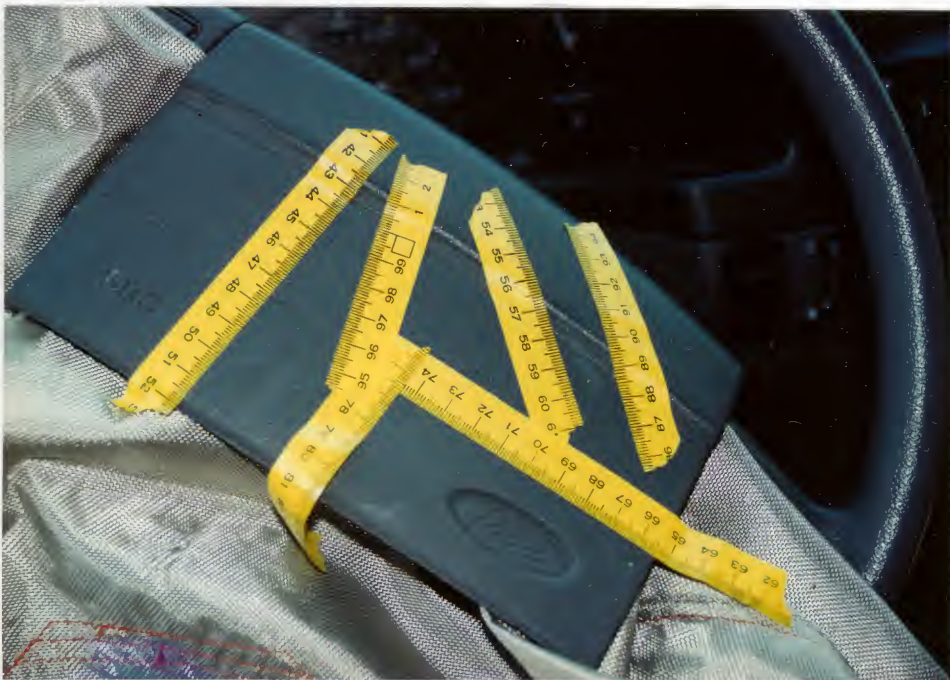
The air bag module flaps exhibited several burnish marks and fabric coloration transfer marks (refer to photographs #44 - #46 on pages A-22, A-23) from contact with the driver during the deployment sequence. A dark blue/black transfer was observed along the entire upper cosmetic relief line located 3.0 cm (1.2") below the top of the upper flap which was consistent in color with the color of the driver's shirt (refer to photographs #57, #58 on page A-29). A significant burnish mark which measured 8.9 cm (3.5") vertically and 3.1 cm (1.25") laterally was located 3.1 cm (1.25") right of the left vertical tear seam and began at the horizontal tear seam line.

A small burnish mark measuring 1.9 cm (0.75") long and 9.5 mm (0.4") wide was oriented in an angular direction on the upper module flap with the upper point located 5.7 cm (2.25") left from the right vertical tear seam line and the lower point located 3.8 cm (1.5") left from the right tear seam line. There was a light burnish mark around the "Ford" insignia located in the bottom right corner of the upper module flap.

45., 46. Views of the driver side air bag module cover before and after the application of the calibrated tape.

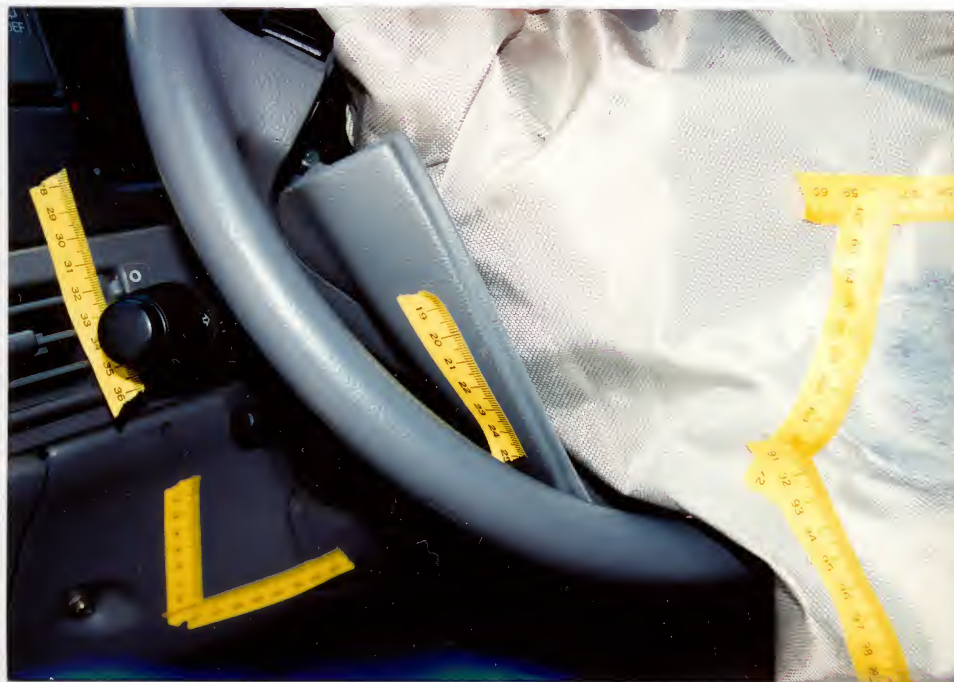
The lower air bag module flap exhibited a dark color burnish mark along the horizontal seam line (refer to photographs #47, #48 on page A-24). The mark measured 12.7 cm (5.0") laterally and 7.9 mm (0.3") vertically and began at the left vertical tear seam line. Refer to the diagram on the page 12 for a detailed schematic of the contact evidence on the driver side air bag module cover. The right side of the flap was displaced forward beyond the steering wheel rim as the result of the air bag deployment sequence and the loading by the unrestrained driver on the air bag (refer to photographs #47, #48 on page A-24).

47., 48. Views showing the position of the lower air bag module flap and the contact evidence along the horizontal tear seam line of the flap.

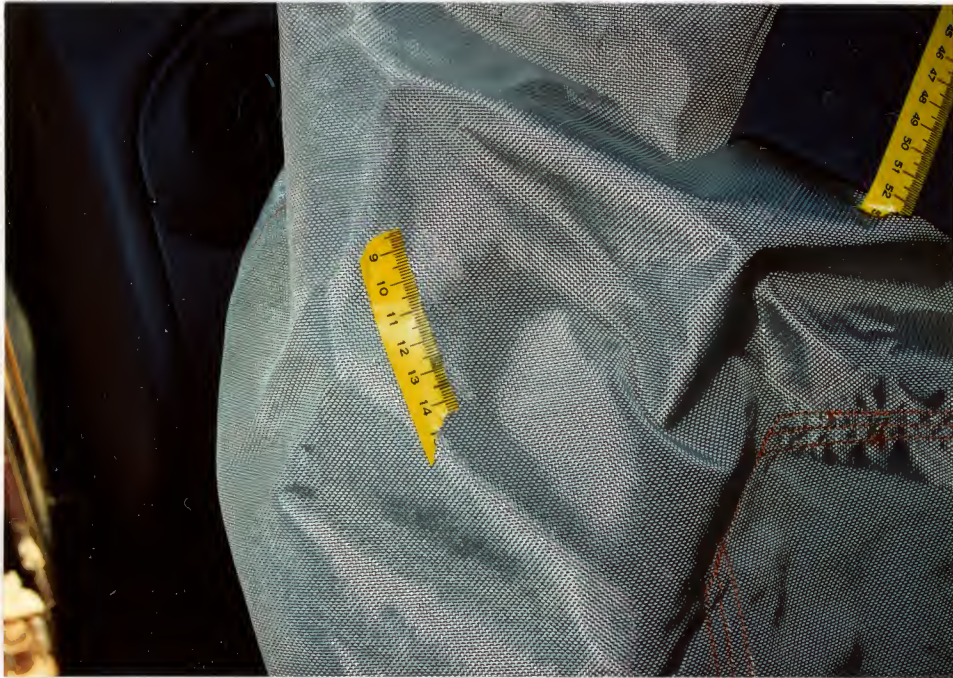
The driver air bag exhibited fabric transfers consistent in color with the color of the driver's shirt (refer to photographs #49, #50 on page A-25). A 2.5 cm (1.0") long light blue transfer was noted on the front surface of the air bag located 12.7 cm (5.0") left of the center target area. A large blue/gray fabric transfer measuring 14.6 cm x 12.7 cm (5.75" x 5.0") was noted on the back surface of the air bag in the six o'clock sector. It was located along the perimeter of the air bag and had an appearance of a heavier transfer coloration along the left side of the transfer pattern (refer to air bag diagrams on pages 13-14 for detailed documentation). This transfer resulted from

49. View showing a small linear blue transfer mark on the front surface of the air bag.

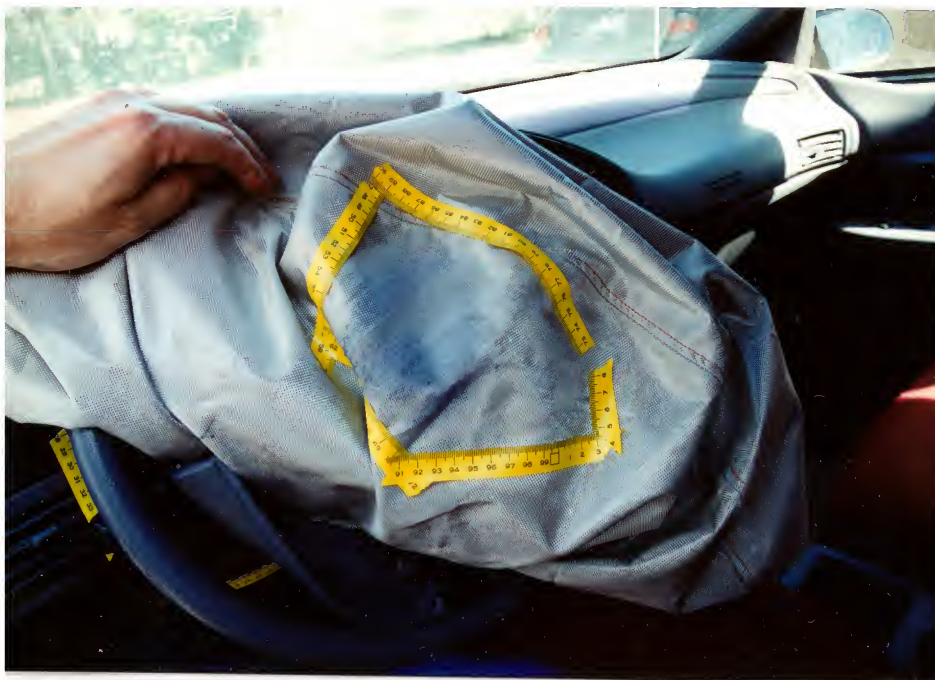
50. View of the large blue/black color transfer mark on the reverse side of the air bag.

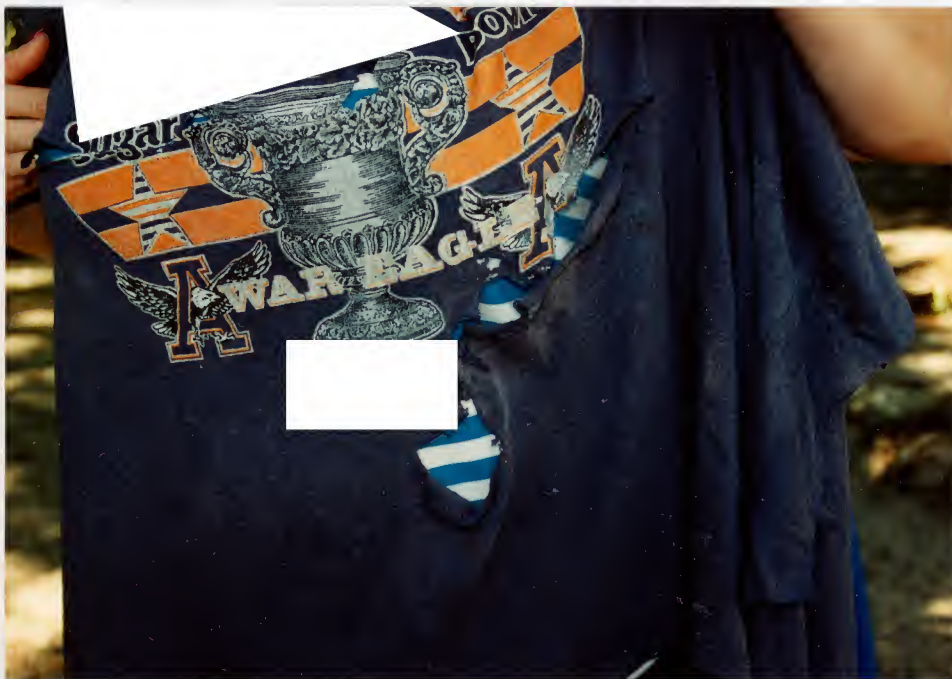
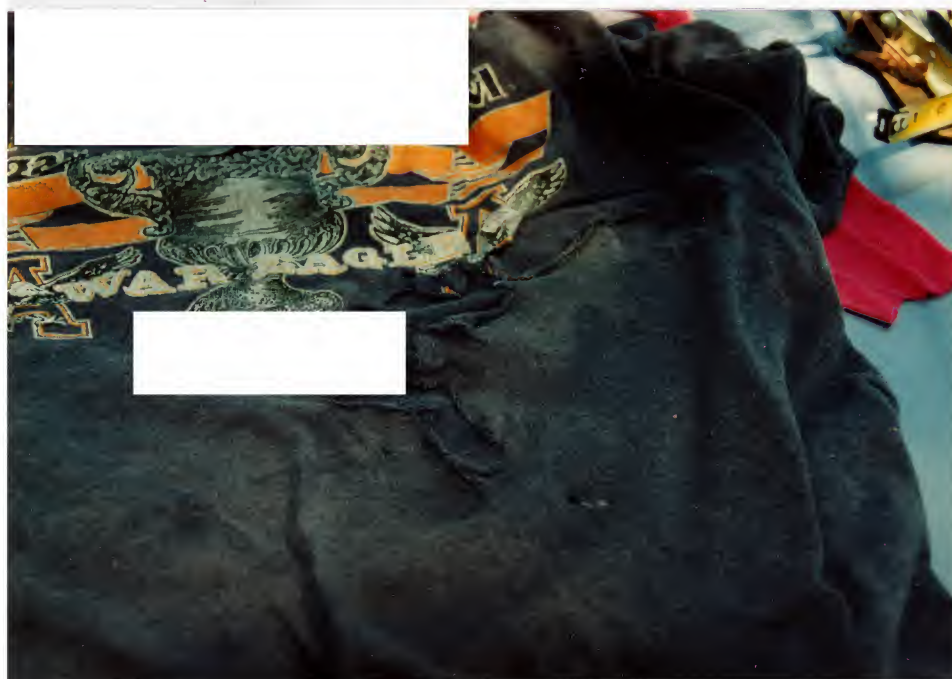
The driver was wearing a dark blue 100 percent cotton pullover shirt with a black and silver trophy cup designer logo on the front side. The garment was ripped in an area over the left side of the chest which resulted from contact by the upper air bag module flap during the supplemental restraint system (SRS) deployment. A blue and gray fabric transfer mark measuring 12.7 cm (5.0") x 14.7 (5.8") was noted on the instrument panel side of the air bag in the 6 o'clock position which was consistent with the color of the driver's shirt.

57., 58. Close-up views showing the tear pattern located along the lower left side adjacent to the word "Orleans" and the surrounding discoloration resulting from contact with the air bag during deployment.

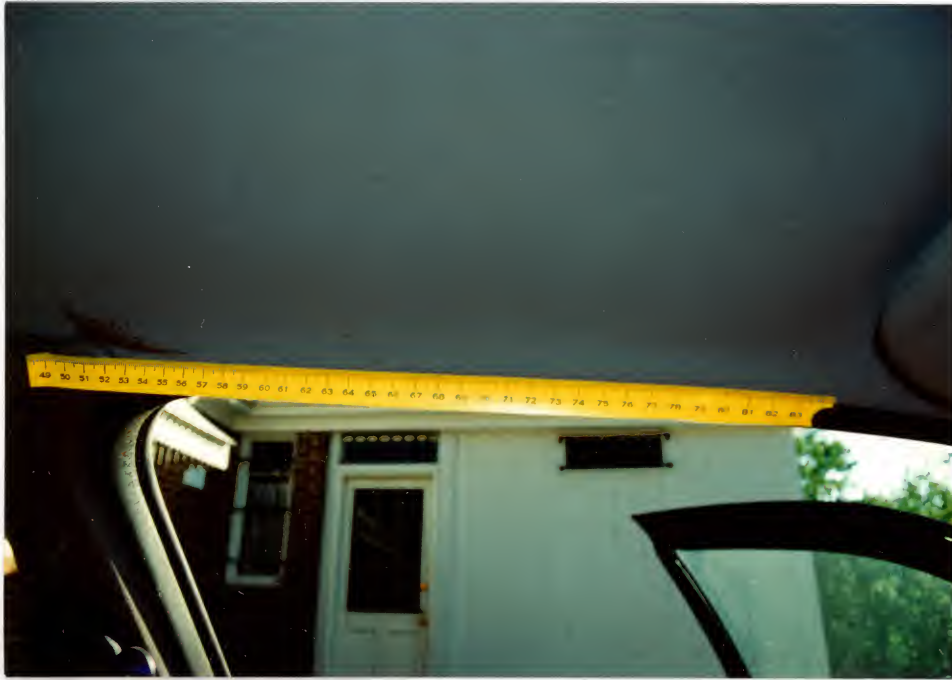
upper torso was then elevated upward and propelled rearward by the expanding air bag. A dark transfer mark was noted on the fabric along the left roof side rail which was attributed to contact by the driver's head as she was propelled rearward. The driver complained of bruising along the top of her head.

65. Close-up view of contact evidence along the left side roof rail.

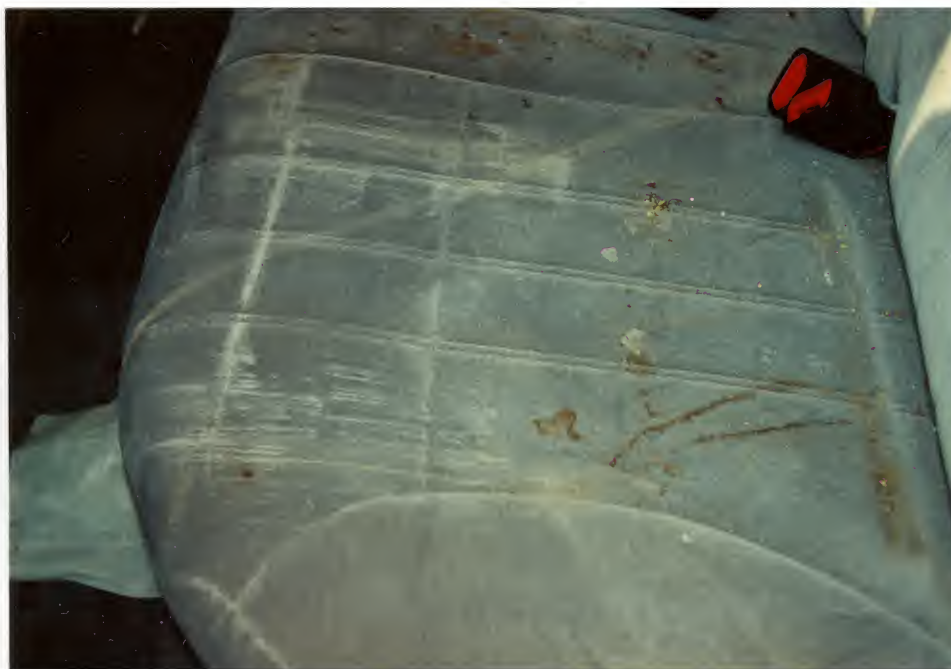
Other interior damage not related to the crash was noted to the left rear seat cushion. The driver indicated the abrasions on the seat fabric were related to the child safety seat used by her three year old son (refer to photograph #68 page A-34).

68. View of the left rear seat cushion showing abrasion of the seat fabric consistent with the installation and use of a child safety seat.

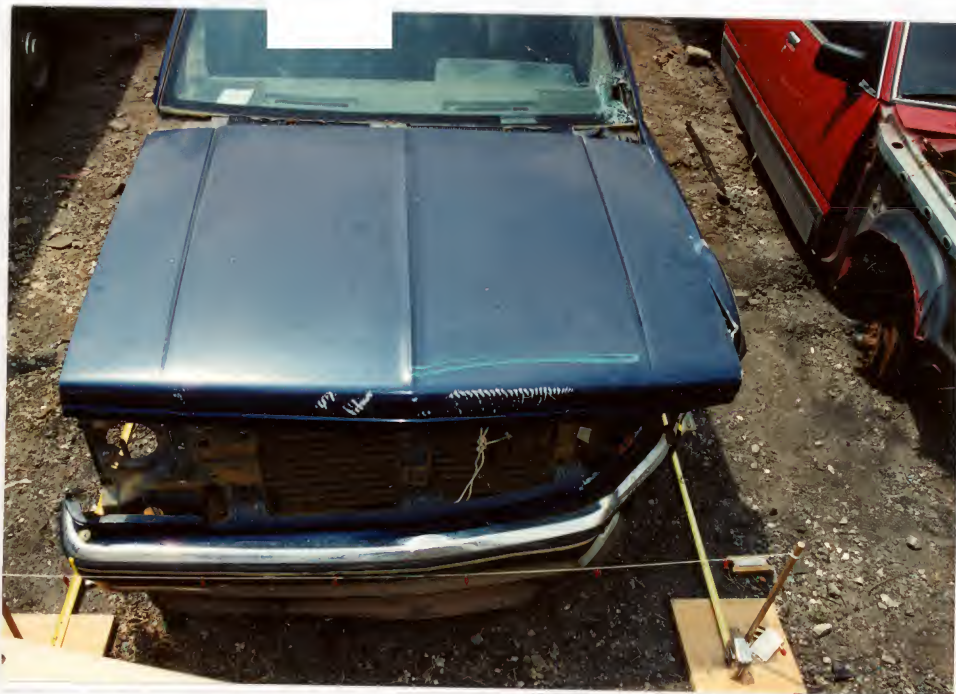
The frontal plane of the 1989 Chevrolet S10 pickup truck struck the frontal plane of Vehicle #1. The length of direct contact on the front bumper measured 38.1 cm (15.0"). The maximum crush of 31.75 cm (12.5") was located at the left front bumper corner. The crush pattern was typical of an off-set frontal impact configuration with deformation concentrated along the left frontal section of the vehicle (refer to photographs #69, #72 - #74 on pages A-35, A-36, A-37). The length of the direct and induced damage measured 143.5 cm (56.5") with crush values as listed below:

69. Frontal view of the 1989 Chevrolet S10 pickup truck (Vehicle #2) showing the overall plane of contact .

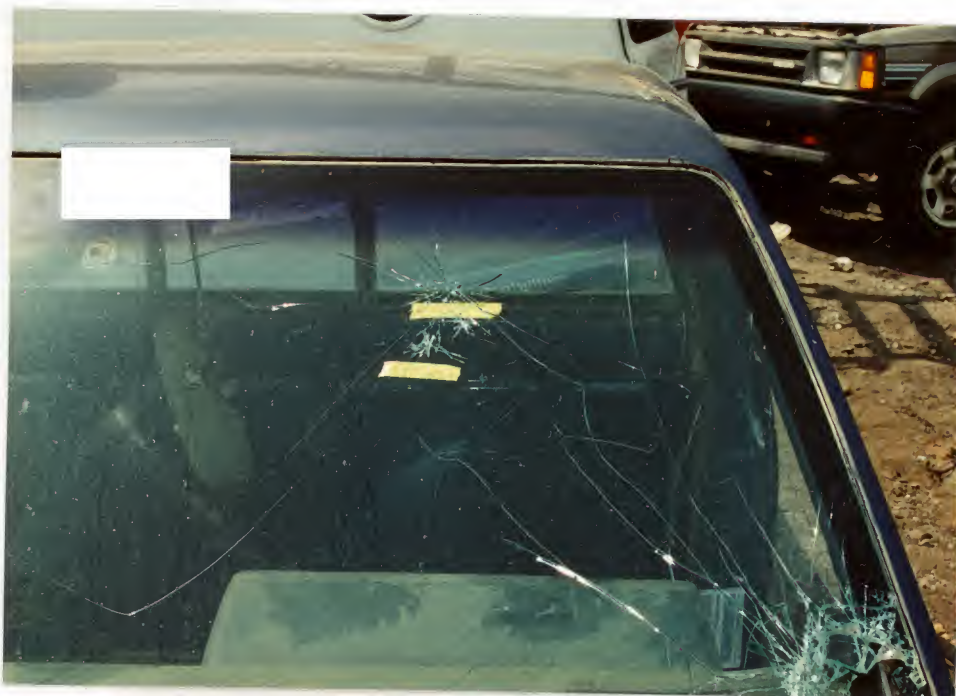
The windshield had two focal spider web pattern fractures which were typical of contact points. One was located 32.4 cm (12.75") left of the vehicle centerline and 12.7 cm (5.0") below the windshield header and the other fracture was located nearby at 29.8 cm (11.75") left of the centerline and 19.1 cm (7.5") below the windshield header. These were attributed to contact by the driver's right hand. There was a hole in the windshield glazing located at the lower left corner adjacent to the upper A-pillar and instrument panel. This resulted from contact by the left rear corner of the hood as it was displaced rearward during the crash.

71. Close-up view of contact damage to the windshield.

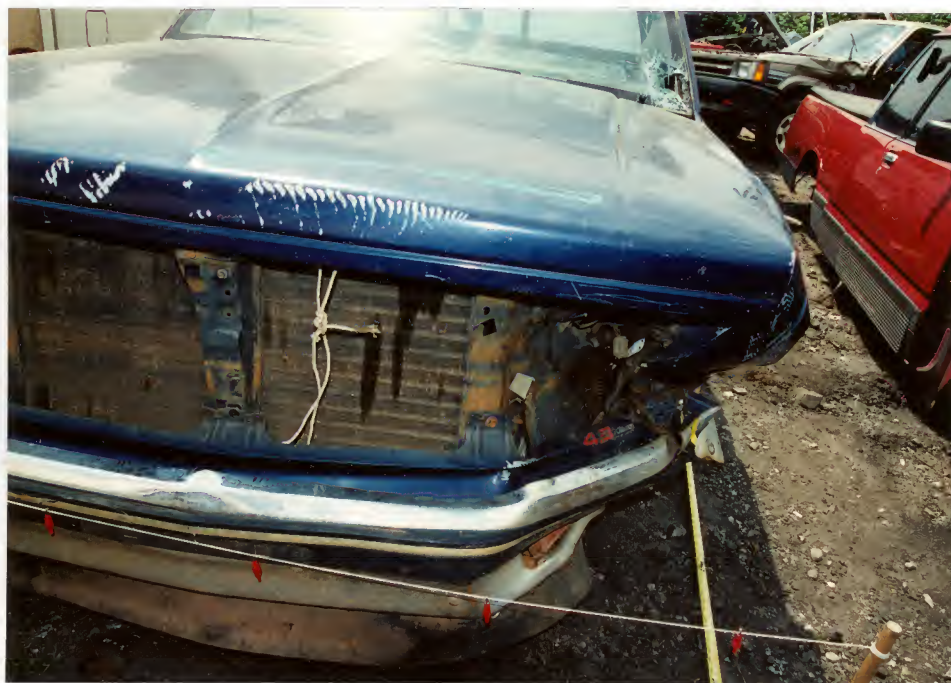
Components damaged in the crash included the front bumper, the left headlight and directional light assembly, the hood, grille, radiator, left front fender, and the windshield.

72. View of the left frontal area showing crash damage.

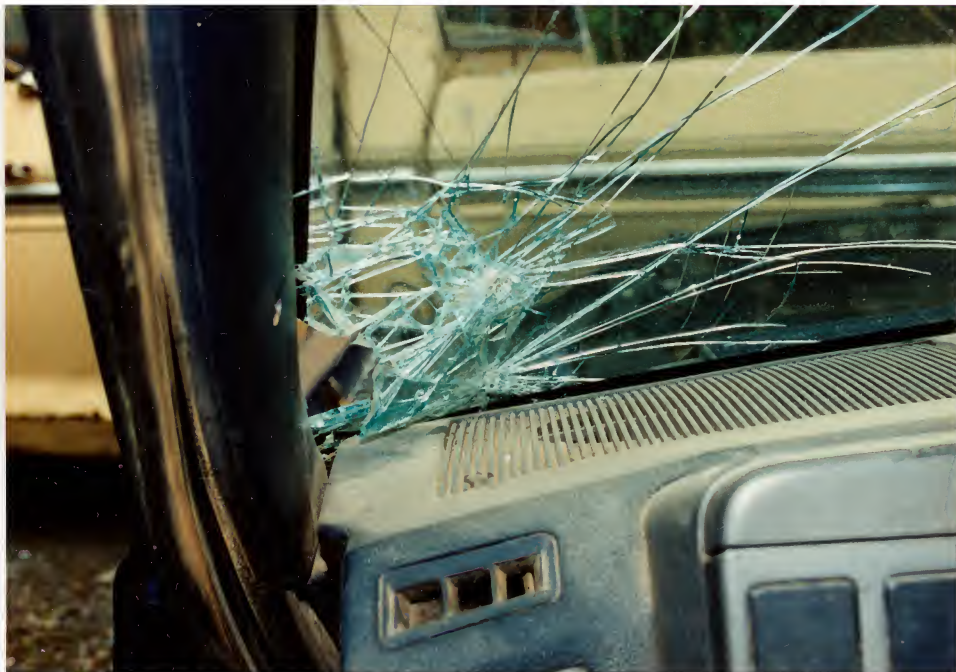
84. Close-up view of the hole in the windshield glazing.
